# Manufacturing and impact behaviour of aeronautic overmolded grid-stiffened thermoplastic carbon plates

F. Neveu, C. Cornu, P. Olivier, Bruno Castanié

F. Neveu, C. Cornu, P. Olivier, Bruno Castanié. Manufacturing and impact behaviour of aeronautic overmolded grid-stiffened thermoplastic carbon plates. *Composite Structures*, 2022, 284, pp.115228. 10.1016/j.compstruct.2022.115228 . hal-04108752

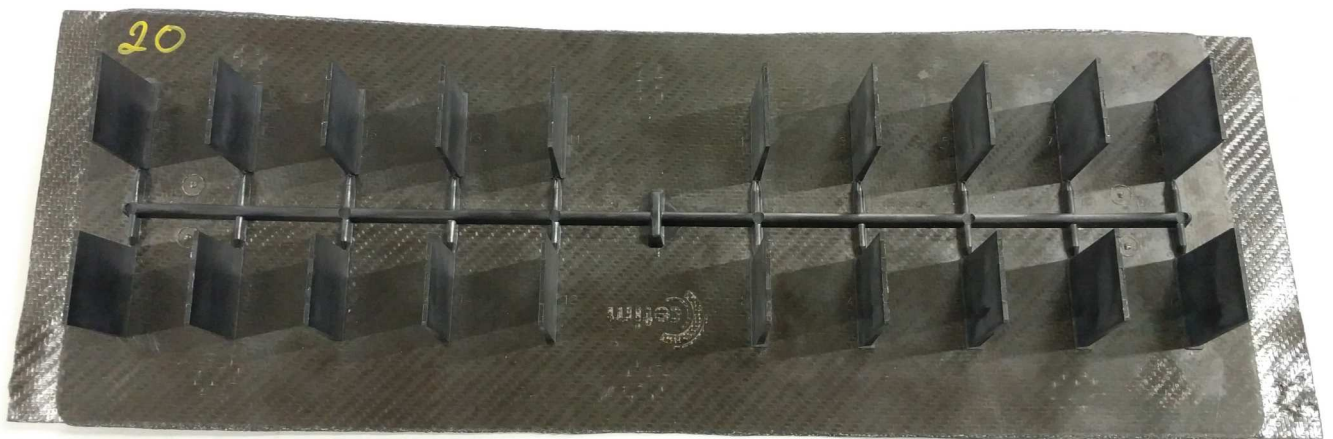
Figure 3. Plate after manufacturing.

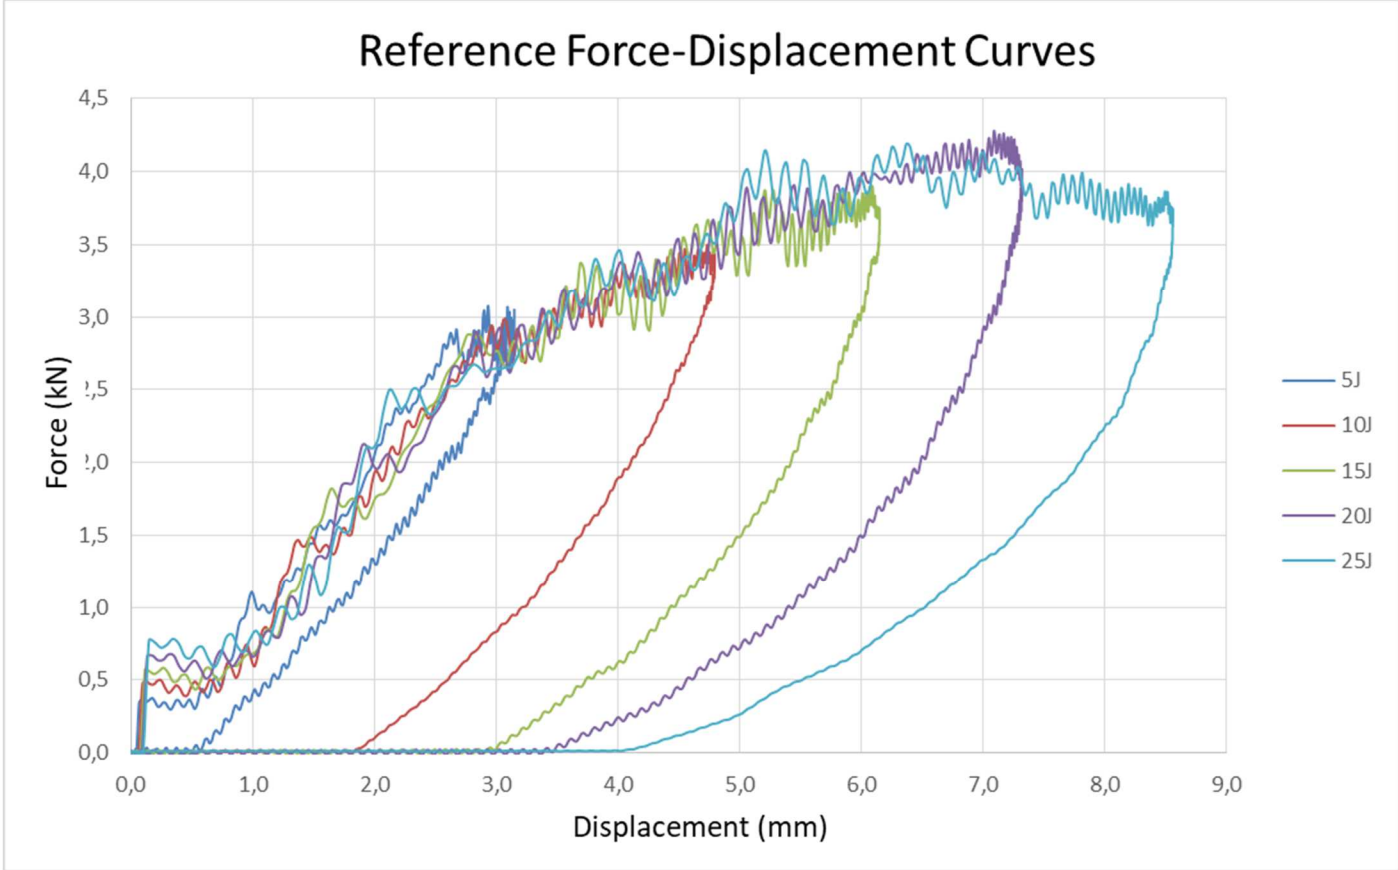
Figure 18. Force-displacement curves for impact tests on Tencate PEI plates without overmolding.

Five tests were carried out, at 5, 10, 15, 20 and 25 Joules, on Tencate specimens 100 x 150 mm<sup>2</sup> without overmolding following the method described in [11] or [30]. The displacement force curves are given in Figure 18. A first contact zone of 0.5 mm is noticeable, followed by an almost linear rise, which is noisy because of the dynamics of the impact, then a change in slope linked to the creation of damage in the plate. These curves are very similar to those of Vieille et al. [12] although the thermoplastics are different (PEEK and PPS). The contact zone may be connected with a phenomenon of clearance linked to the plate/assembly contact due to plate springback. The change in slope is attributed to the beginnings of fiber breakages at 90° and 0° [12], which then multiply. The measurement of the residual indentation, due to the relaxation effects, was carried out more than 72

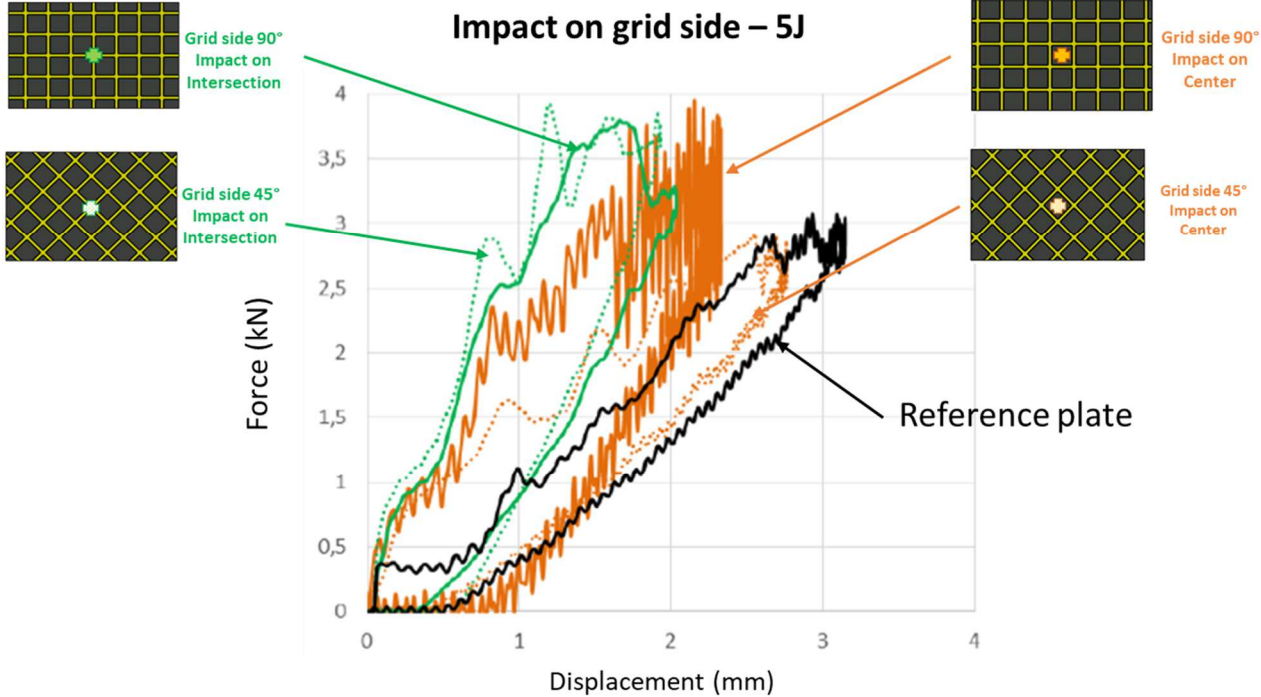
Figure 22. Displacement force curves for an impact at 5 J, overmolded grid side.

The displacement force curves for an impact at 5 J are given in Figure 22 for the molded grid side, and in Figure 23 for the plate side. Globally, for the plate side impacts, the response appears identical, the contact phase is similar and is probably due to the curvature of the plate generated by the springback. The energy absorbed for the reference plate is 1.64 J and for the overmolded plates it is higher, oscillating between 1.74 J. and 2.97 J. The

maximum delamination is reached for the minimum absorbed energy, which suggests that the debonding occurred early and consumed little energy. It could therefore be a manufacturing defect. However, in this case of early debonding, there is thus a contribution of the grid to the energy absorption and the grid is also damaged. In the case of the impact on the overmolded grid side, there is a significant difference in behaviour according to whether the impact is on the grid or at the bottom of a square. The energy absorbed is greater and varies from 2.31 J to 3.01 J, the minimum being obtained for the same configuration as before, with a debonding of 60% of the grid. There is no longer a contact zone and the initial slopes are greater, which is logical given the contribution of the grid to the bending. The maximum contact forces are also increased relatively to the reference plate when the impact falls directly on the grid. In this case, the damage is minimal and the grid does play a protective role. On the other hand, during an impact at the bottom of a square, especially for the 90° case, the signal is very noisy, which probably corresponds to the grid/plate debonding up to 60% as noted. However, this phenomenon is not present for the plate with a 45° grid, which shows more similarity with the impact on the reference plate.

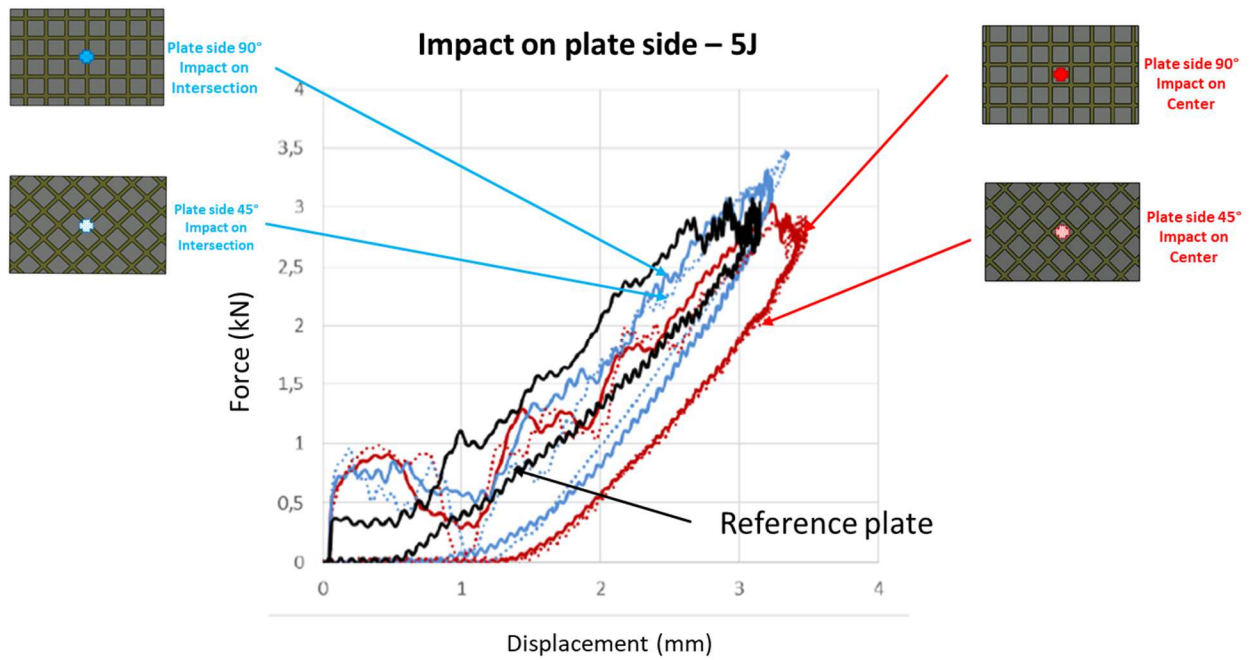
Figure 23. Displacement force curves for an impact at 5 J, plate side.

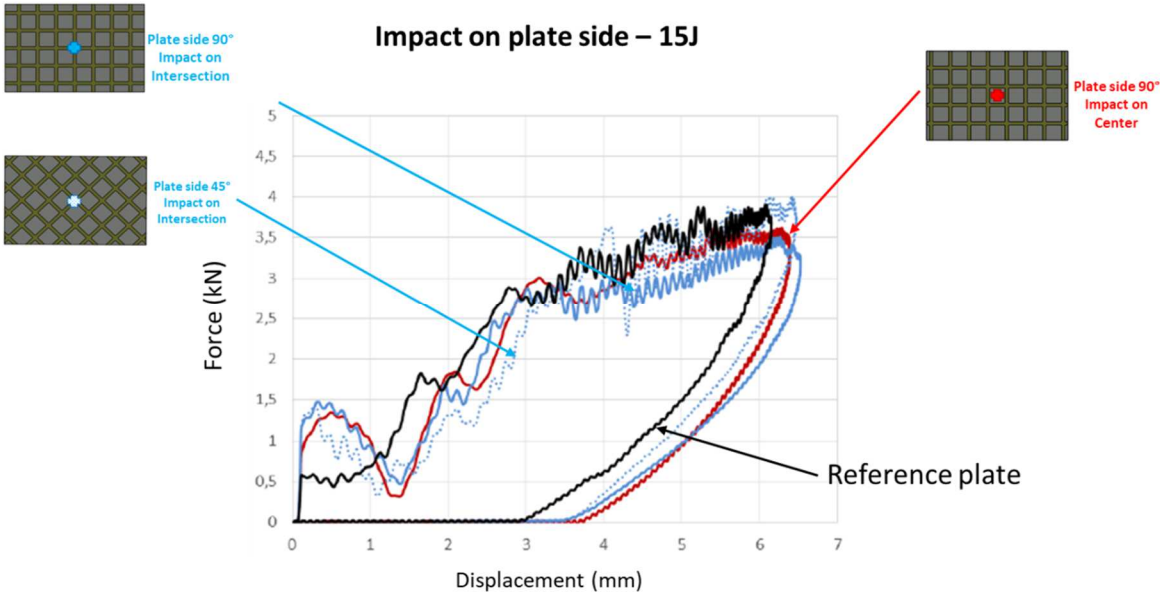
Figure 27. Displacement force curves for an impact at 15 J, plate side.

The displacement force curves for an impact at 15 J are given in Figure 26 for the overmolded grid side, and in Figure 27 for the plate side. Two tests are missing due to an experimental problem but do not change the observed trends. Globally, the behaviour is identical with, of course, the greatest damage when the grid side is impacted. The grid is destroyed in both cases of location of impact and the debonding is complete, or at 80%

when the bottom of the mesh is hit. On the other hand, it is noticeable that, during the impacts on the plate side, the behaviour is very homogeneous and very similar to that of the plate alone.
